Hot Spots: Where Con Ed Found Electrified Metal

In the weeks since an East Village woman died after her dogs stepped on an electrified metal plate in the street, Con Edison has found scores of service-box lids, manhole covers and lampposts with stray current passing through them. Although most of these hot spots involved fairly low voltages, some were strong enough to kill.

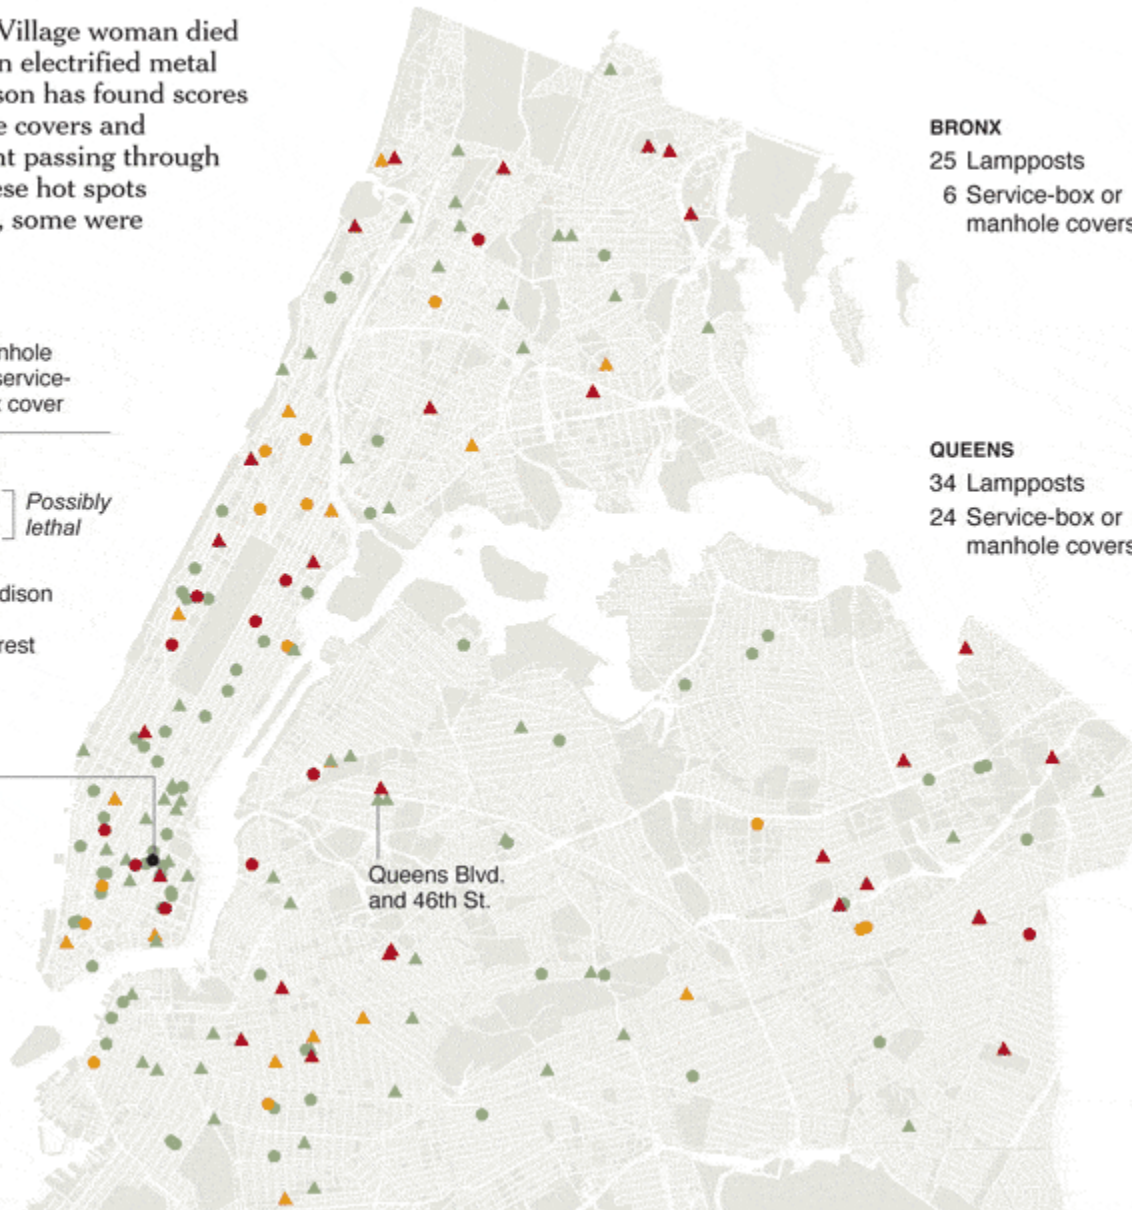
Electrified equipment	Lamp-post	Manhole or service-box cover	
Less than 50 volts	▲	●	} <i>Possibly lethal</i>
50 to 99 volts	▲	●	
100 volts and greater	▲	●

Data based on surveys by Con Edison since Jan. 16. Information for lampposts is through Feb. 3; the rest is through Feb. 4.

Site of electrocution

MANHATTAN
30 Lampposts
53 Service-box or manhole covers

STATEN ISLAND
1 Lamppost

BRONX
25 Lampposts
6 Service-box or manhole covers

QUEENS
34 Lampposts
24 Service-box or manhole covers
